⁵⁰ ⁷²
November 1967 ARS 41-138

ANCHORING AUTOMOBILE BODIES FOR STREAMBANK PROTECTION¹

Bruce J. Blanchard²

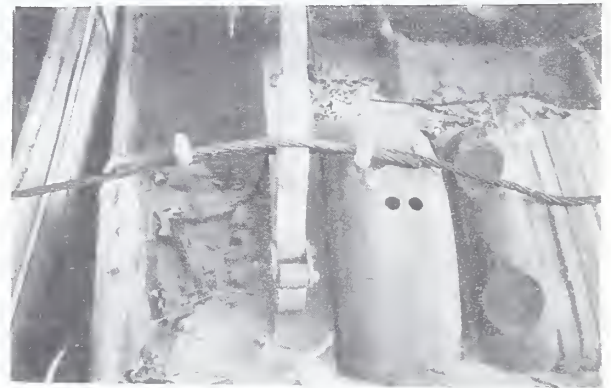
change in direction of attack. Only bodies with frames should be purchased. Bodies are held in place on the lateral cables by clamping a splice to the frame as shown in figure 8. Anchor cables resist both movement downstream and movement away from the bank, yet are flexible enough to allow the entire assembly to settle when the stream bed is degrading. Additional flexibility for vertical movement of the bodies may be provided by loosening the cable clamps on excess cable attached to the anchor piling. Bodies should be placed top down to facilitate anchoring, and reduce turbulence in the streamflow.

Figure 8.--A simple cable arrangement for locking automobile bodies together.
